## Image Tearing Causes and Solutions

Technical Application Note TAN2010003

Revised November 18, 2011

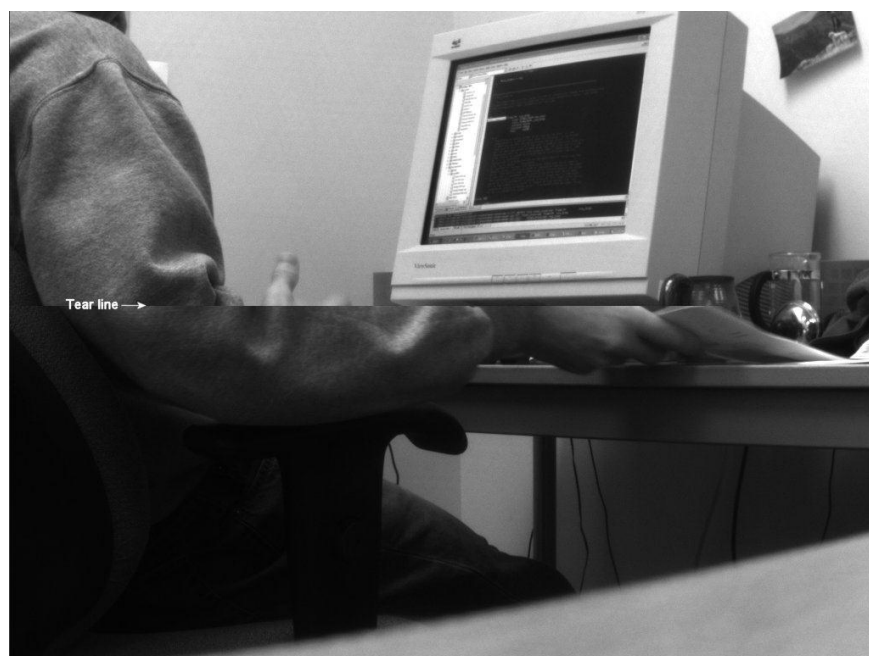
Figure 1

The following images show examples of image tearing. The first example shows an offset between the top and bottom halves of the image:

Horizontal tearing, such as the example shown in Figure 1, is often a video display issue, rather than a problem with the actual image data. To verify that the image data is not corrupted, run the SaveToAVI example available with the FlyCapture SDK, and analyze each frame of the AVI. If the image data is, in fact, corrupt, refer to the sections below.

If the image data is not corrupt, the most likely reason is that the frame rate of the image display is not synchronized with the refresh rate of the monitor. The monitor video display buffer fills with data, then gets displayed. However, sometimes the display buffer only partially fills before the monitor grabs it and displays it to the screen. This causes the tearing effect, and is more noticeable if the camera is being panned and there is a significant difference in image content between frames. For recommendations on how to reduce this image tearing, [contact our Technical Support team](#).

1. Verify if the issue is related to the video display refresh rate. See 1.3.1 above.
2. Disable power-saving features, as discussed in 1.3.2 above.
3. If possible, lower the overall data rate, such as by lowering the frame rate, or by using a Format\_7 mode that transmits lower-resolution images using region of interest and/or pixel binning.

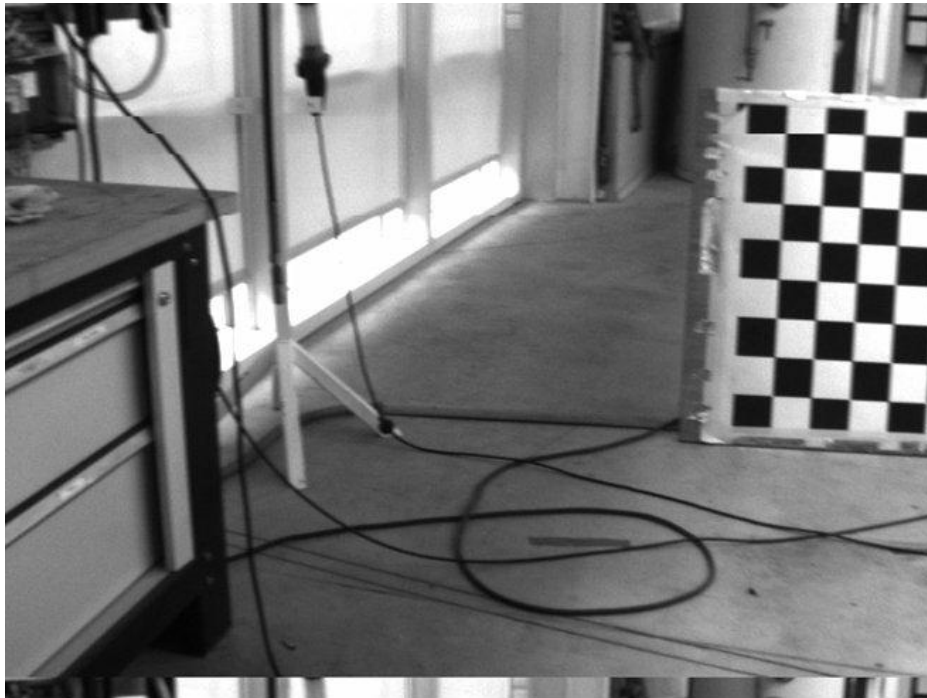
**Figure 2**

This example shows a broken image, in which the bottom portion contains data from another image:

In particular, when the PCI bus saturates, the system cannot keep up with the data rates going across it. As a result, images cannot be pulled off the 1394 PCI card fast enough. The isochronous FIFO buffers on-board the card gradually fill with image data from the camera, and eventually a general FIFO overflow occurs. These overflows can result in:

- Tears through the middle of an image due to data packets being dropped and the current image being filled by data from the next image (Figure 2 above).
- Broken images that are made up of many different images (Figure 3 above).
- Images that are dropped completely (see [Related Article 141](#) below).
