## Image Tearing Causes and Solutions

Technical Application Note TAN2010003

Revised November 18, 2011

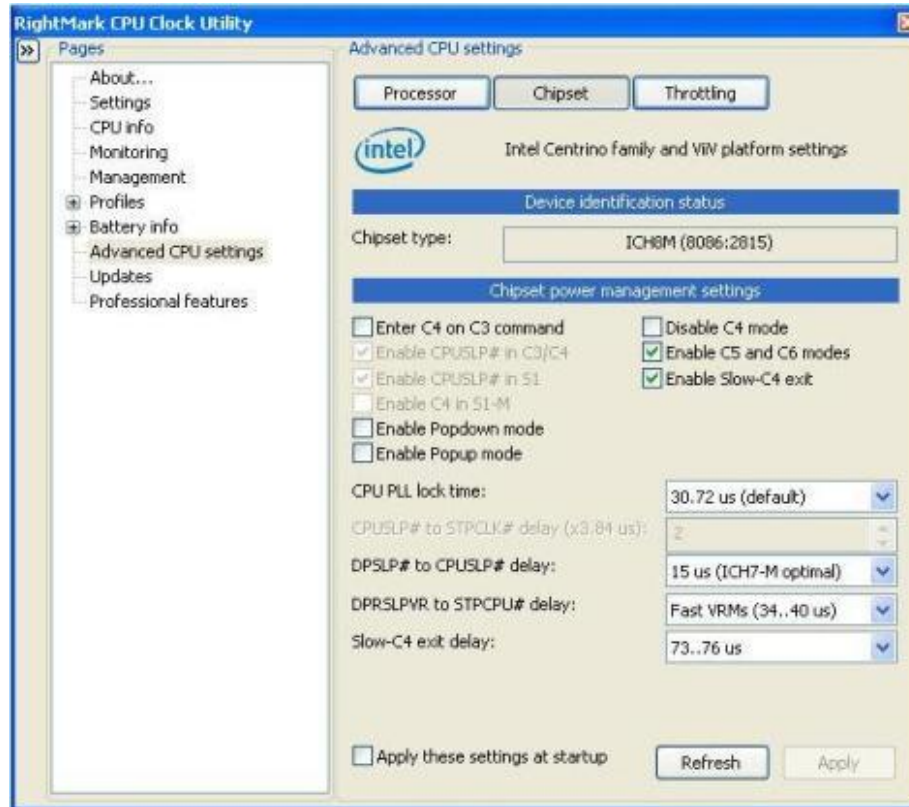
#### Popdown/Popup Mode on Laptop/Notebook Computers

On laptop/notebook systems, changing the Popdown or Popup Mode may fix the issue. To do this, use the RightMark CPU Clock Utility, downloadable from: [http://cpu.rightmark.org/download/rmclock\\_235\\_bin.exe](http://cpu.rightmark.org/download/rmclock_235_bin.exe). The relevant settings are found in the Advanced CPU settings window, as shown in the following screenshot:
